Culler Lake Bathymetry: Potential Changes Following Dredging

Spring 2013 Sampling Methods Class:
 J. Bruland, M. Dybala, N. Gunther, A. Hoffman, J. Jones, L. Kelley, J. Neidinger, M. Olszewski, C. Rogers, A. Waldron
 Department of Biology, Hood College, 401 Rosemont Avenue, Frederick, MD 21701

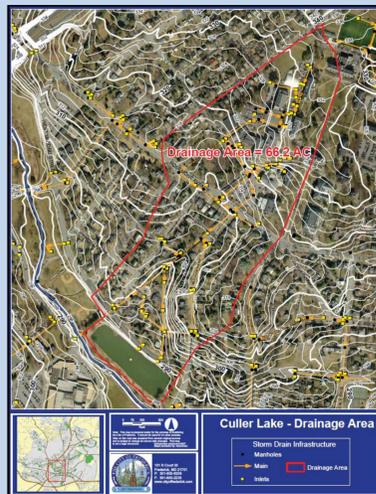
Figure 1. Map of stormwater drainage into Culler Lake. The red line indicates that drainage area. The yellow lines and symbols denote drains and underground piping for stormwater. Note that a portion of this area collects water for Culler Lake and that a portion of the stormwater is discharged directly into Carroll Creek.

Culler Lake, constructed in 1939, is a multipurpose impoundment located in the heart of Baker Park. The lake serves as a recreational resource and a stormwater management pond. Culler Lake receives inflow from Carroll Creek and stormwater drainage from 66 acres of urban land (see Figure 1), which includes residential housing and much of the Hood College campus. We created two bathymetric maps of the lake: one as it currently stands and another that would be the result of dredging activity. Our hope is this information can be used to assist in future lake restoration and stormwater remediation plans.

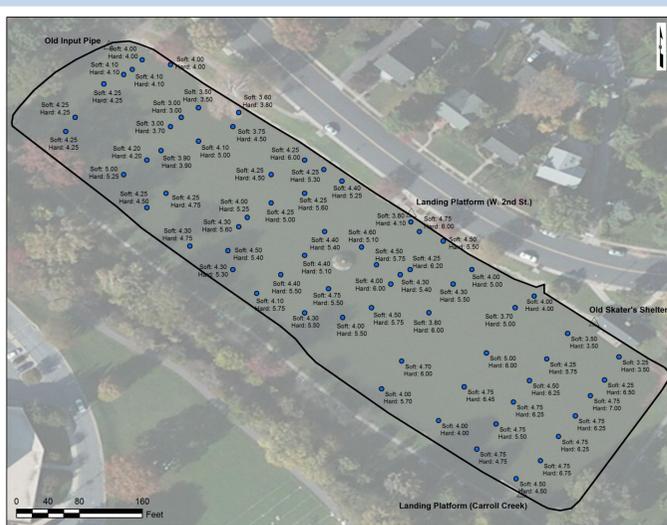
Figure 2. Map of Culler Lake indicating sampling points and their corresponding soft and hard bottom water depths.

We recorded both soft and hard bottom measurements throughout Culler Lake. Soft bottom measurements are the depths from the water surface to the top of the sediment layer. Hard bottom measurements are the depths from the water surface to the constructed base of the lake bottom, as indicated by a section of PVC pipe being forced as deeply as possible into the sediment. The difference between these two measurements is an indication of the depth of the sediment. Depth readings were recorded over eleven transects spanning the length of the lake. GPS was used to record five to seven waypoints along each transect

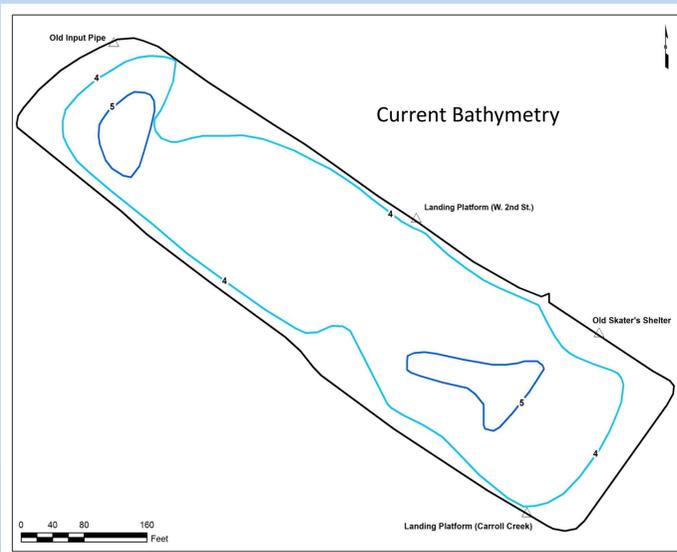
Figure 3. Map of Culler Lake indicating the current depth contours (i.e. the soft-bottom depth).

Depth (ft)	Surface Area (ft^2)	Depth Interval (ft)	Volume (yd^3)
0	149,770	0 to 4	18,980
4	107,622	4 to 5	1,851
5	9,817	5 +	12
Total Vol. (yd^3)			20,843

- The majority of the sediments are deposited in the southeastern two-thirds of the lake.
- There was a large discrepancy between lake outflow and Carroll Creek inflow during a non-storm period.
- The shallow nature of the lake may allow sediment re-suspension due to winds.

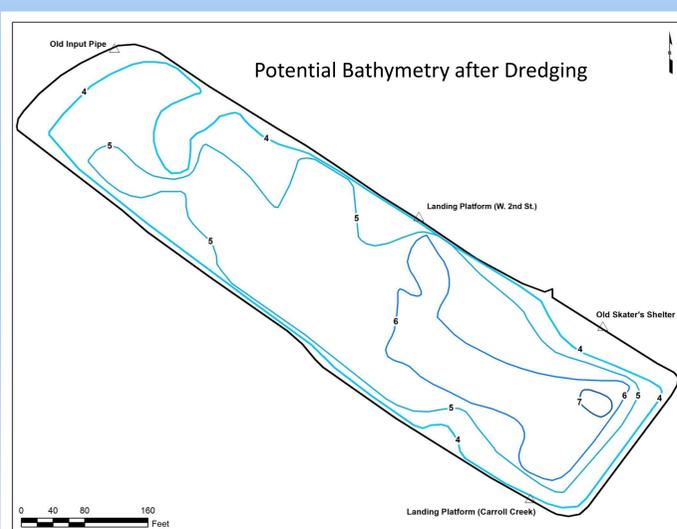
Figure 4. Map of Culler Lake indicating potential contours after dredging (i.e. the hard-bottom depth).

Depth (ft)	Surface Area (ft^2)	Depth Interval (ft)	Volume (yd^3)
0	149,770	0 to 4	19,728
4	117,225	4 to 5	3,588
5	77,889	5 to 6	1,780
6	23,500	6 to 7	348
7	688	7	8
Total Vol. (yd^3)			25,453

Volume of Dredged Material (yd^3) 4,610
